Tension test results for post rafter purlin connection system. See photo 1.

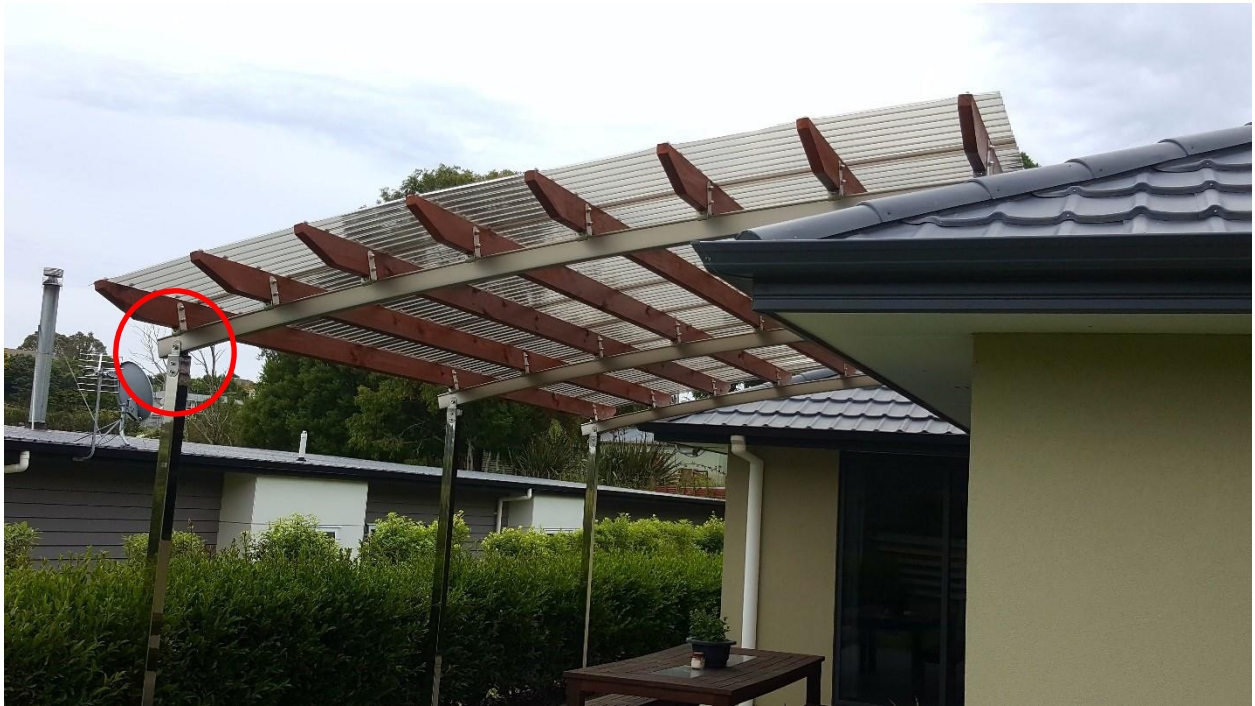
Photo 1 – showing the position of the connection within the final structure

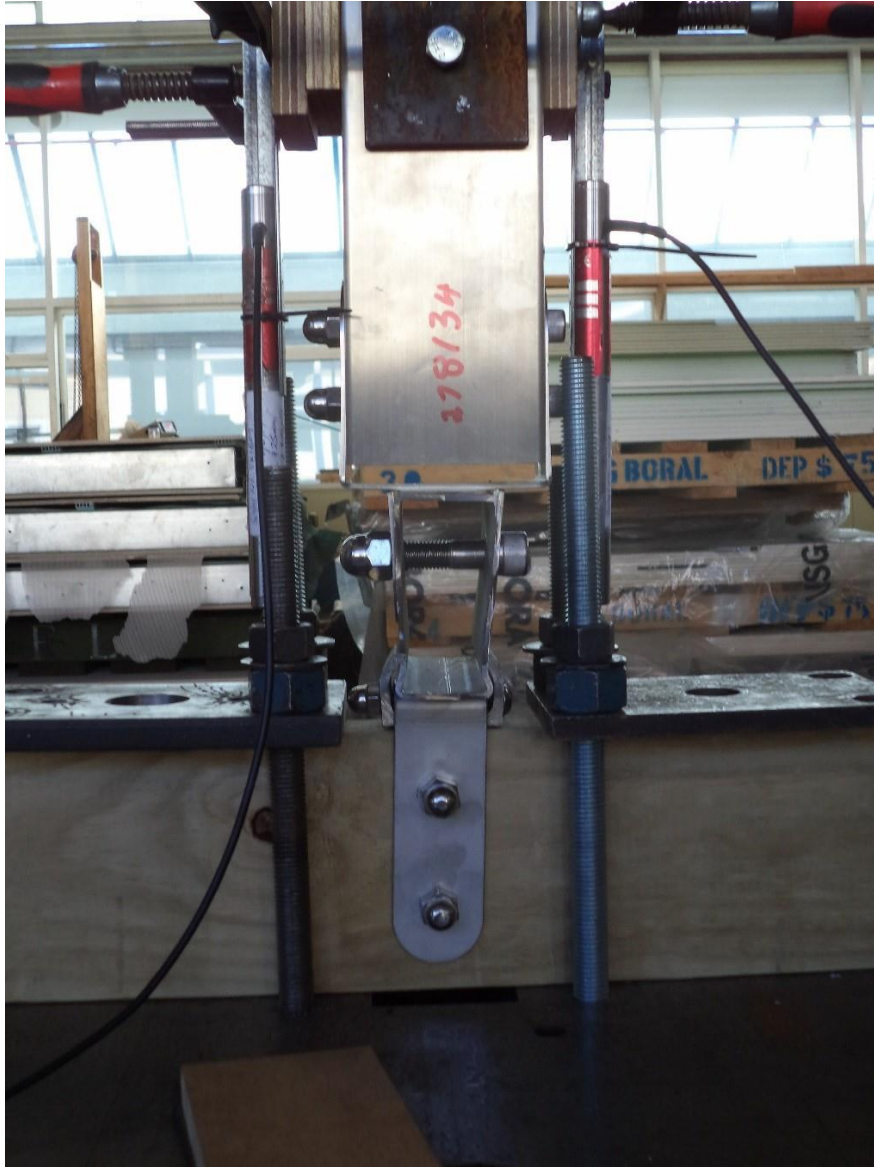
Photo 2. Specimen No. 278134 in test rig after failure had occurred.

Testing was conducted by clamping the purlin down to the bed of the scion Weidemann grade 1 universal testing machine. The square stainless steel post was then connected to the testing machines movable crosshead.

Two displacement transducers were mounted on either side of the post measuring the average movement between the post and the purlin during the test

See photo 2. Test speed was set at 4mm/min. Load displacement during the test was recorded, along with maximum load and failure mode.

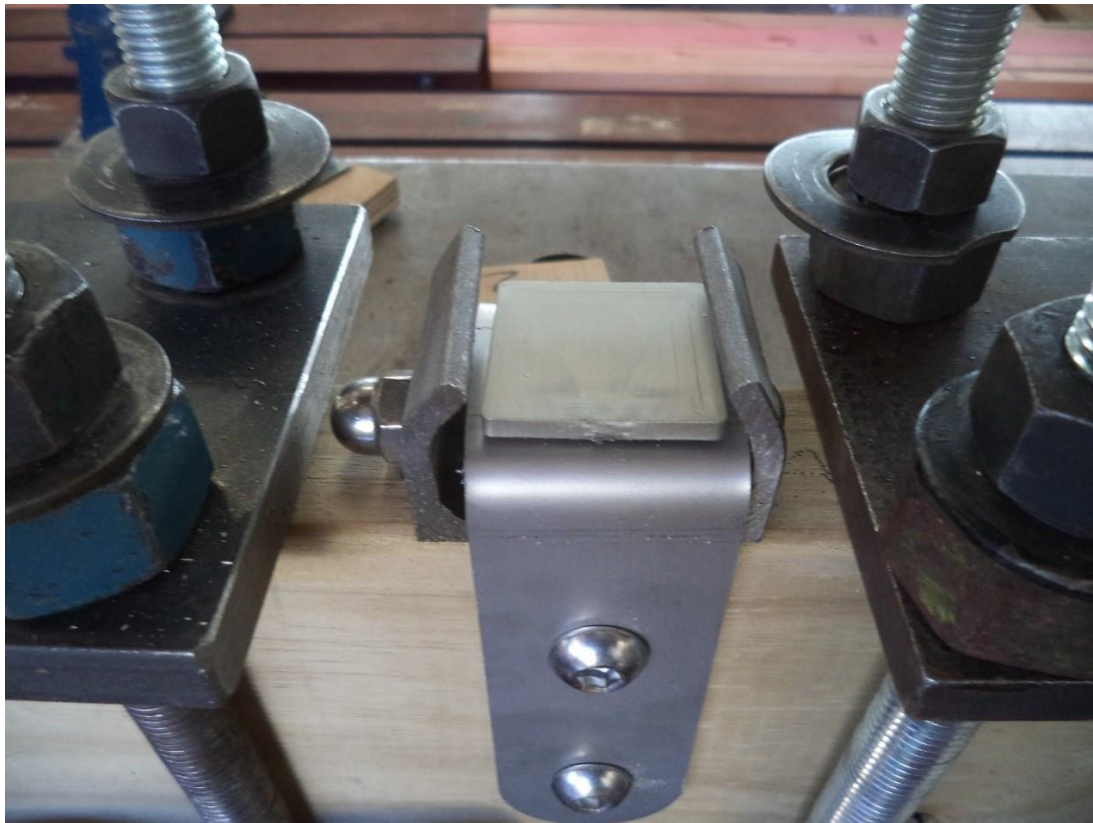
Photo 3. Specimen No. 278134 Rafter / Purlin connection bracket in test rig after failure had occurred.

The observed failure mode for all three specimens was deformation of the bracket connecting the purlin to the rafter. There appeared to be no significant deformation of any of the rafter post connections. see Photo 3

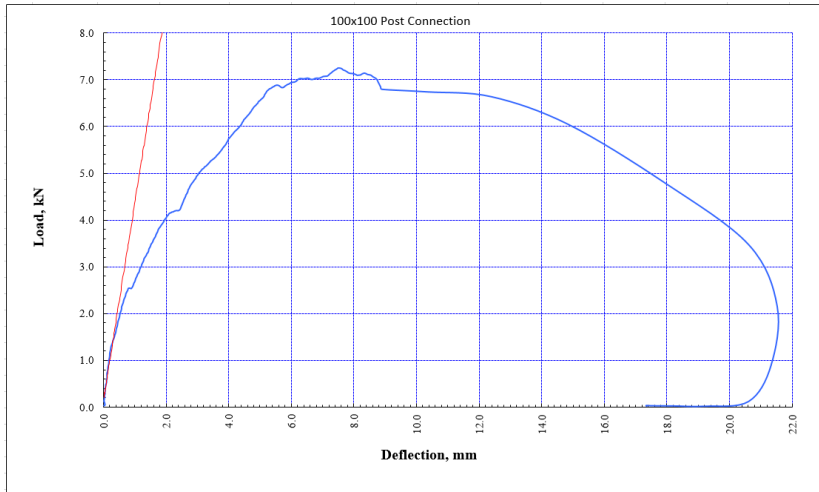
Figure 1. Load displacement plot for Specimen 278134 100x100mm post

Table 1 provides a summary of the test results for the three specimens tested. Figures 1, 2, & 3 show the load and average displacement plots generated.

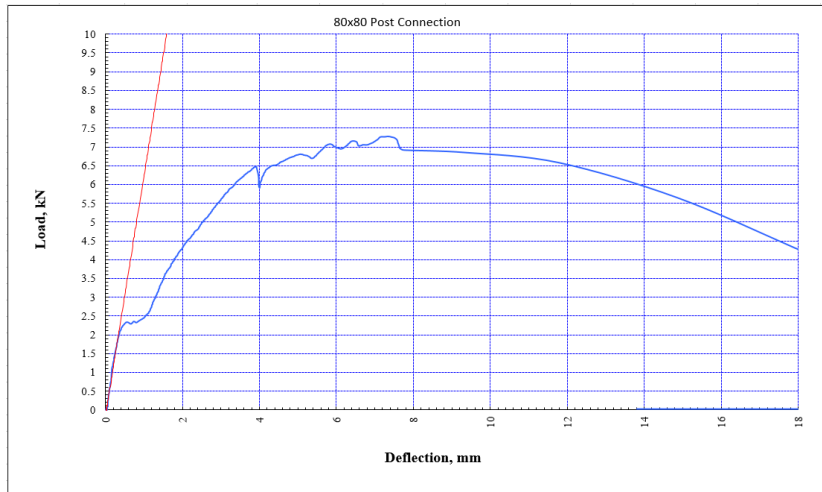
Figure 2. Load displacement plot for Specimen 278135 80x80mm post

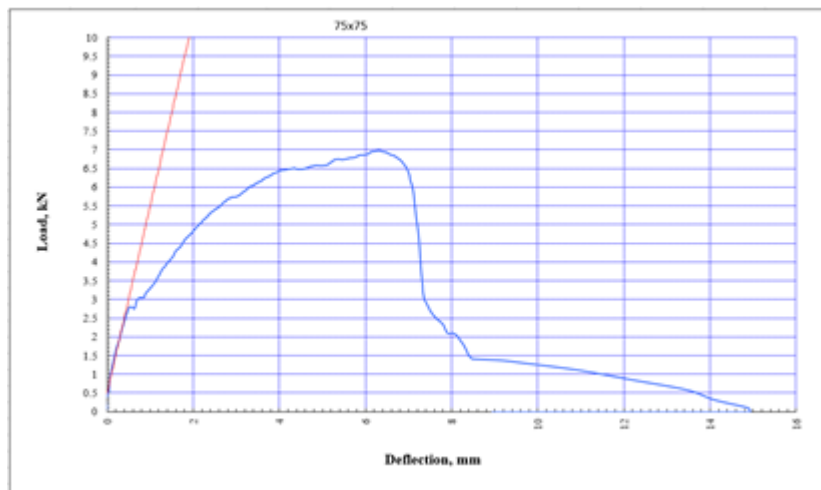
Figure 3. Load displacement plot for Specimen 278136 75x75mm post
